Subject: Field Oversight Activities Report (21 May – 6 June 2007)
Monitoring Well Installation/Ground Water Sampling
Gulfco Marine Maintenance Site RI/FS Oversight
U.S. Environmental Protection Agency Region 6
Remedial Action Contract 2
Contract: EP-W-06-004
Task Order: 0006-RICO-06JZ

**Field Oversight Activities Report
Monitoring Well Installation/Ground Water Sampling
(21 May – 6 June 2007)**

**Gulfco Marine Maintenance Site
Freeport, Brazoria County, Texas
EPA Identification No. TXD055144539**

**Remedial Action Contract 2 Full Service
Contract: EP-W-06-004
Task Order: 0006-RICO-06JZ**

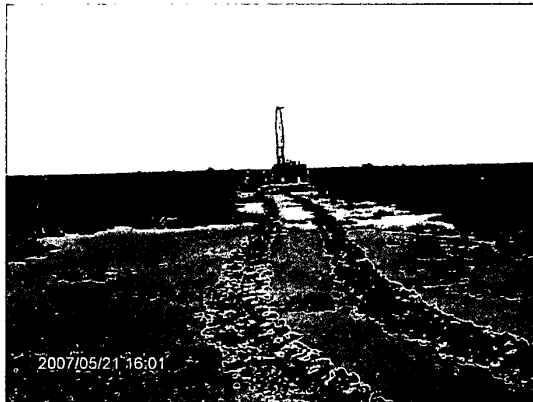
Photograph 1 Date: 21 May 2007
Site: Gulfco Marine Maintenance Superfund Site
Description: Buggy hollow-stem auger (HSA) rig sets up to install well OMW21

At 1640 hours, MMS set up the buggy rig at monitoring well location **OMW21**, which is proposed as a Zone A (shallow) well (Appendix A, Photograph 1). At 1710 hours, MMS pushed the first 5-foot-long core barrel (Appendix A, Photographs 2 – 4). During drilling activities, PBW monitored the work area and the in-ground HSAs for volatile organic compounds (VOCs) using a MiniRae® 2000 photo-ionization detector (PID) (Appendix A, Photograph 5). Based on lithologic interpretation of the soil cores, PBW directed MMS to stop drilling OMW21 at a total depth of 18 feet bgs. MMS set the 2-inch PVC well casing at a total depth of 18 feet bgs with a 10-foot screen (screened from 8 to 18 feet bgs).

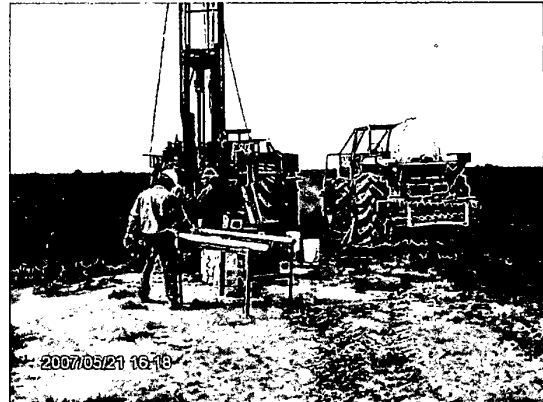
Photograph 2 Date: 21 May 2007
Site: Gulfco Marine Maintenance Superfund Site
Description: Buggy HSA rig installing OMW21

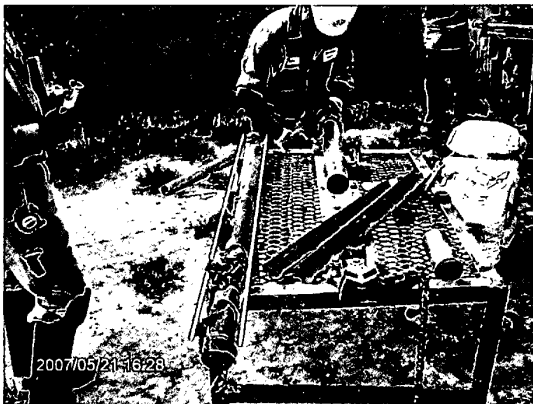
Photograph 3 Date: 21 May 2007
Site: Gulfco Marine Maintenance Superfund Site
Description: Core sample from OMW21

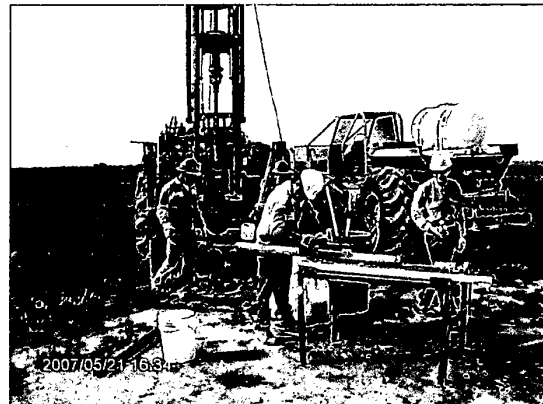
Photograph 4 Date: 21 May 2007
Site: Gulfco Marine Maintenance Superfund Site
Description: OMW21

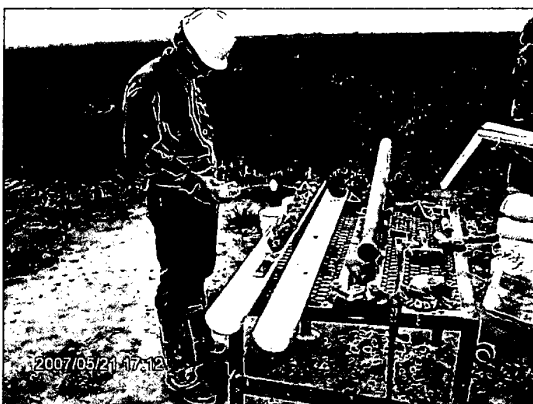
Photograph 5 Date: 21 May 2007
Site: Gulfco Marine Maintenance Superfund Site
Description: Pastor, Behling & Wheeler, LLC (PBW) using photo-ionization detector (PID) to monitor volatile organic compounds (VOCs) at OMW21

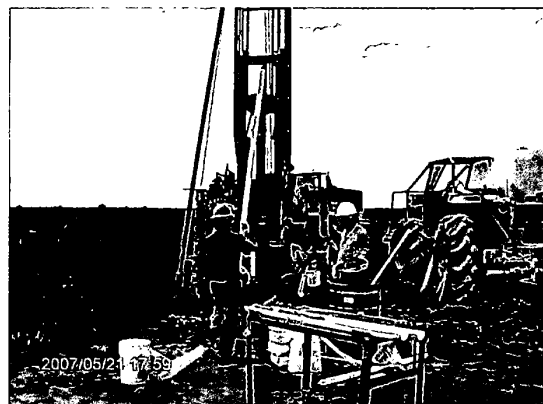
Photograph 6 Date: 21 May 2007
Site: Gulfco Marine Maintenance Superfund Site
Description: Setting 10-foot screen at OMW21 (2-inch-diameter polyvinyl chloride [PVC] with 0.010-inch slots)

At 1900 hours, after recovering the drill rod that had been dropped down the well, MMS set the well casing and poured the sand and bentonite chips around the casing annulus (Appendix A, Photographs 6 – 7). MMS cut the well casing flush with the ground surface, which caused PBW some concern about the possibility of rainfall and storm water infiltration. MMS sealed the well with a “J-plug” and agreed to locate coupling to extend the height of the OMW21 well casing above ground surface.

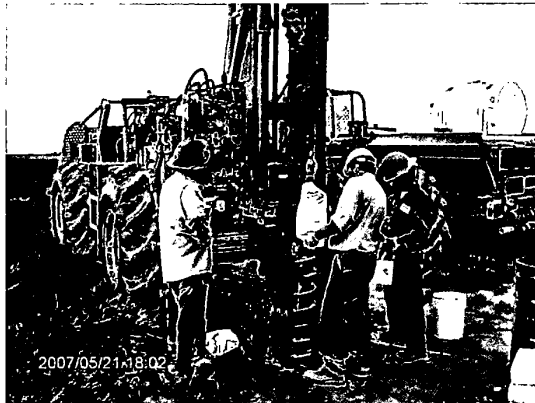
Photograph 7 Date: 21 May 2007
Site: Gulfco Marine Maintenance Superfund Site
Description: Pouring sand around well annulus at **OMW21**

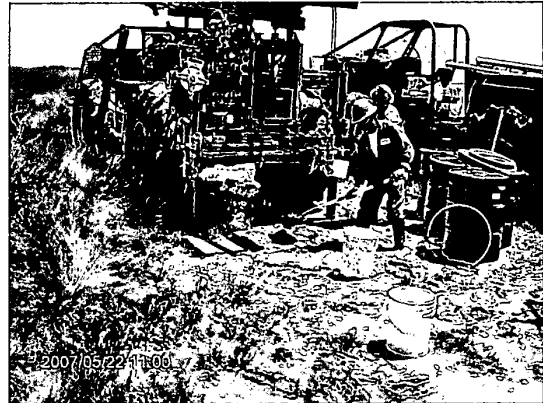
Photograph 8 Date: 22 May 2007
Site: Gulfco Marine Maintenance Superfund Site
Description: Clearing water and mud around **OMW21**

At 1115 hours, PBW and MMS mobilized to proposed well location OMW27B, which is proposed as a Zone B (deep) well and is located immediately adjacent to OMW21. Upon arrival, EA observed that OMW21 was under water. After bailing water out of the well, MMS installed 3 – 4 feet PVC with coupling to extend the well casing above ground surface; no glue or adhesive was used that may have compromised ground water quality within the well (Appendix A, Photographs 8 – 9).

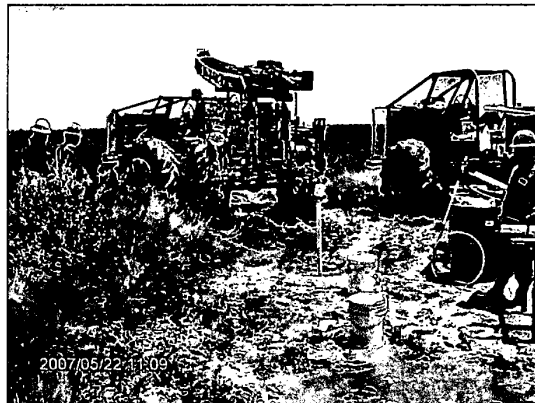
Photograph 9 Date: 22 May 2007
Site: Gulfco Marine Maintenance Superfund Site
Description: Additional coupling to extend **OMW21** above ground surface

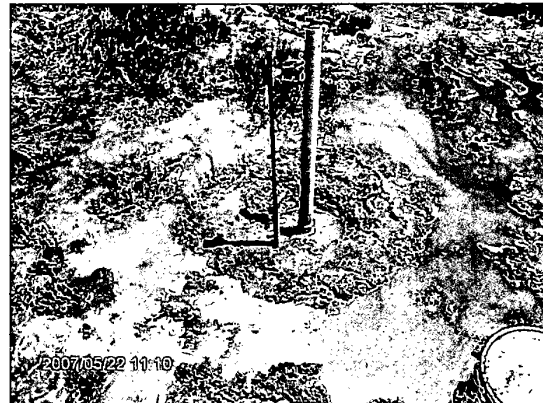
Photograph 10 Date: 22 May 2007
Site: Gulfco Marine Maintenance Superfund Site
Description: **OMW21** (shallow Zone A well)

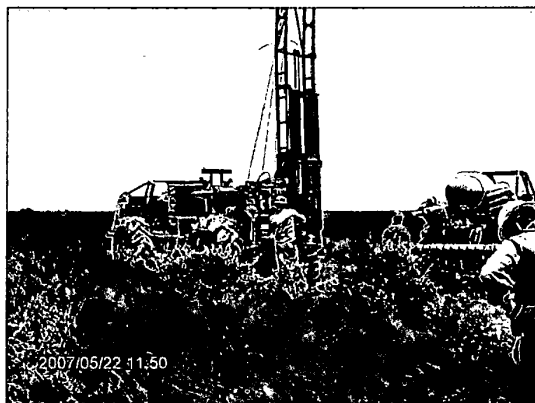
Photograph 11 Date: 22 May 2007
Site: Gulfco Marine Maintenance Superfund Site
Description: Buggy HSA rig setting up at **OMW27B** (deep Zone B well)

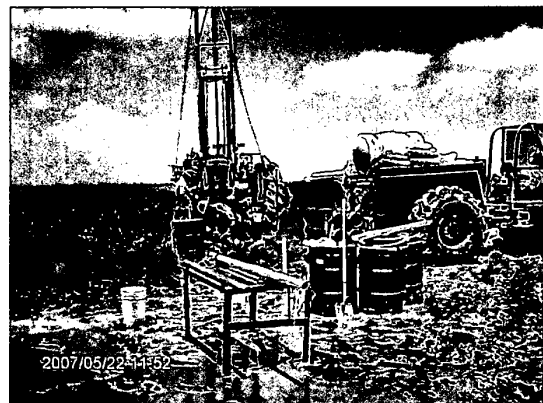
Photograph 12 Date: 22 May 2007
Site: Gulfco Marine Maintenance Superfund Site
Description: Buggy HSA rig drilling **OMW27B**

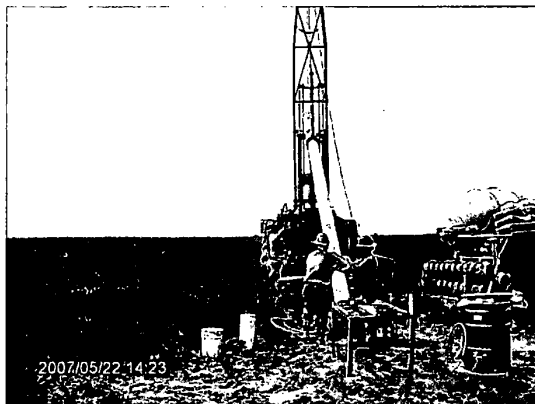
Photograph 13 Date: 22 May 2007
Site: Gulfco Marine Maintenance Superfund Site
Description: Preparing to install 18 feet of surface casing at **OMW27B** (8-inch-diameter PVC casing)

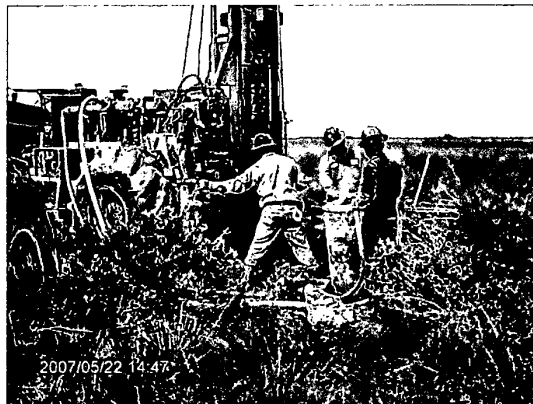
Photograph 14 Date: 22 May 2007
Site: Gulfco Marine Maintenance Superfund Site
Description: Preparing to grout surface casing at **OMW27B**

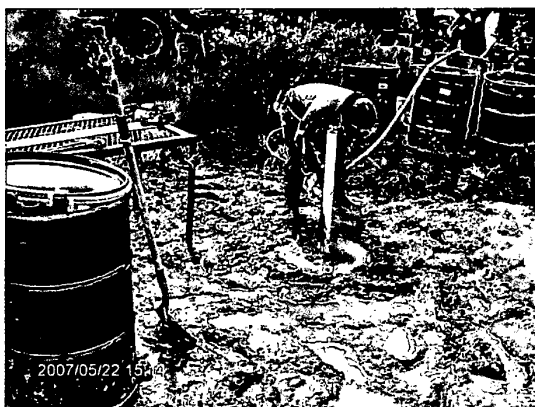
Photograph 15 Date: 22 May 2007
Site: Gulfco Marine Maintenance Superfund Site
Description: Applying additional grout at **OMW21**

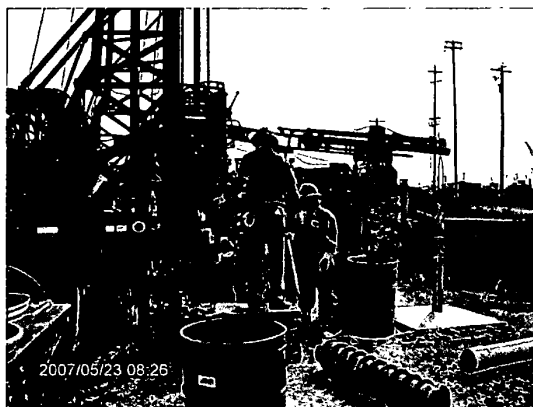
Photograph 16 Date: 23 May 2007
Site: Gulfco Marine Maintenance Superfund Site
Description: Truck-mounted HSA rig setting up at **ND4MW24B** (deep Zone B well)

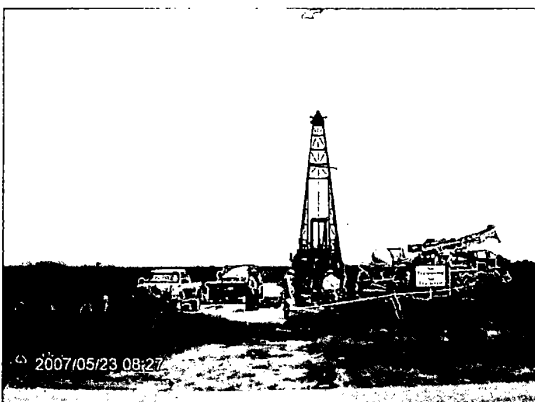
Photograph 17 Date: 23 May 2007
Site: Gulfco Marine Maintenance Superfund Site
Description: Drilling **ND4MW24B**

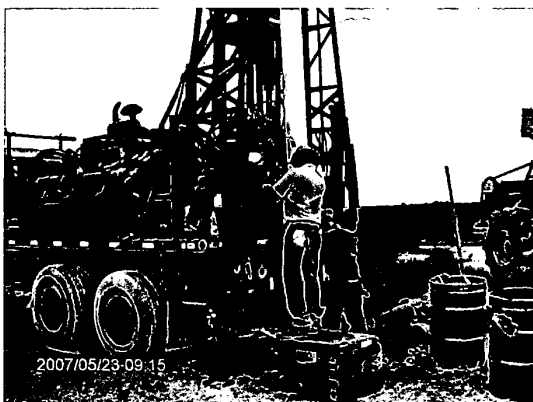
Photograph 18 Date: 23 May 2007
Site: Gulfco Marine Maintenance Superfund Site
Description: Setting 19 feet of surface casing at **ND4MW24B** (8-inch-diameter PVC casing)

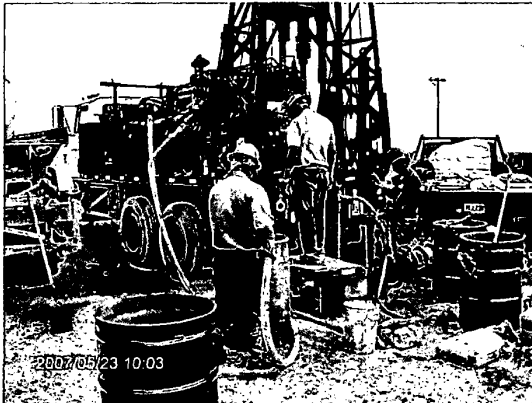
Photograph 19 Date: 23 May 2007
Site: Gulfco Marine Maintenance Superfund Site
Description: Grouting surface casing at ND4MW24B

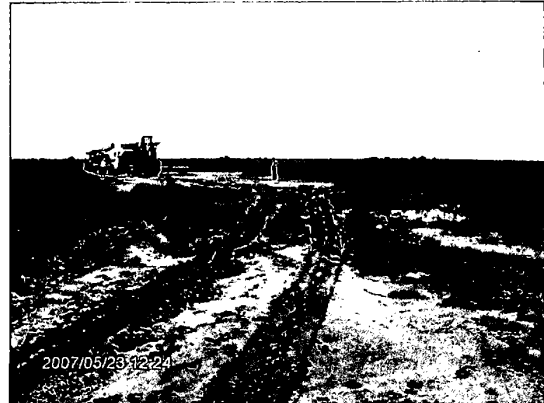
Photograph 20 Date: 23 May 2007
Site: Gulfco Marine Maintenance Superfund Site
Description: Truck-mounted HSA rig setting up at NG3MW19 (shallow Zone A well)

At 1345 hours, MMS began drilling at shallow well location **NG3MW19** using the smaller 8-inch OD HSA (4¼-inch ID) (Appendix A, Photographs 20 – 22). At a depth of 15 feet bgs, MMS stopped drilling to evaluate lithologic samples in core barrels. PBW noted a saturated sand at the top of the 10- to 15-foot bgs interval, with wet silty, sandy clay throughout. PBW directed MMS to drill down another 2 feet with the next core barrel. In the 15- to 17-foot bgs interval, PBW noted clay from 15 – 16 feet bgs and small coarse sand mixed with shell hash from 16 – 17 feet bgs. PBW then directed MMS to fill the borehole with bentonite pellets (PelPlug®) from total depth to 14 feet bgs in order to seal off the lower sand encountered below 16 feet bgs. MMS set the 2-inch PVC well casing at a total depth of 14 feet bgs with a 10-foot screen (screened from 4 to 14 feet bgs). Headspace field screening of subsurface soil samples with a PID did not detect any VOCs above background values. At 1605 hours, MMS completed pouring sand into the well annulus and began equipment decon.

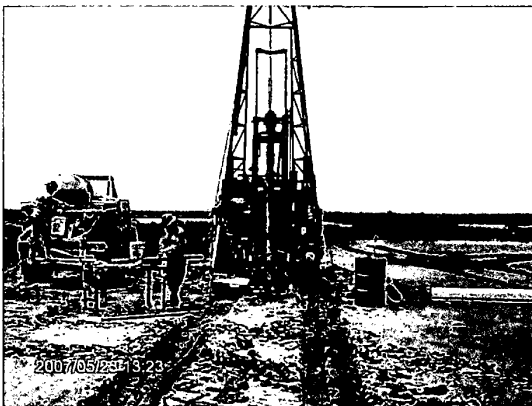
Photograph 21 Date: 23 May 2007
Site: Gulfco Marine Maintenance Superfund Site
Description: Drilling NG3MW19

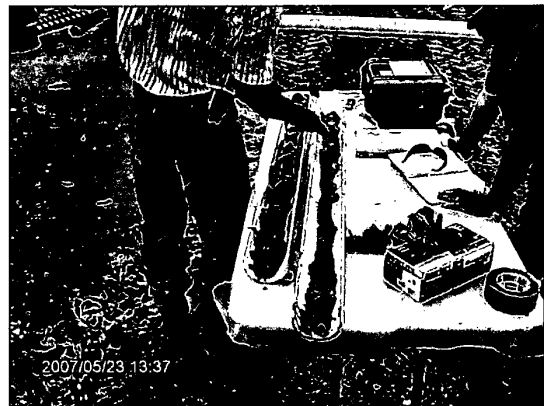
Photograph 22 Date: 23 May 2007
Site: Gulfco Marine Maintenance Superfund Site
Description: Logging soil cores at NG3MW19

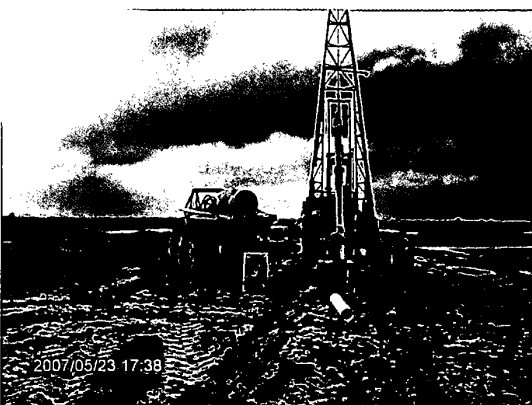
At 1800 hours, MMS began drilling at deep well location **NG3MW25B** using the 12-inch OD HSA (8-inch ID). Upon reaching a total depth of 15 feet bgs, MMS set the 8-inch-diameter PVC surface casing (Appendix A, Photograph 23). At 1900 hours, MMS grouted the surface casing annulus (Appendix A, Photograph 24).

Photograph 23 Date: 23 May 2007
Site: Gulfco Marine Maintenance Superfund Site
Description: Setting 15 feet of surface casing at NG32MW25B (deep Zone B well)

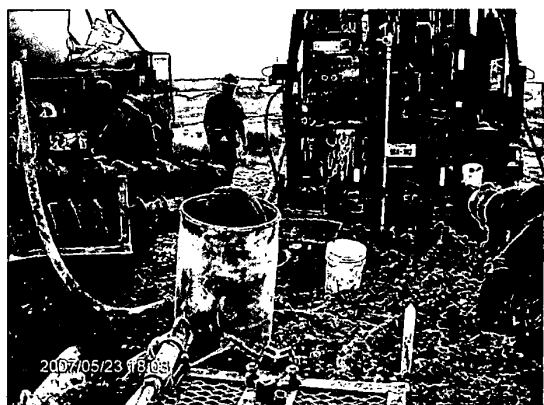
Photograph 24 Date: 23 May 2007
Site: Gulfco Marine Maintenance Superfund Site
Description: Grouting surface casing at NG32MW25B

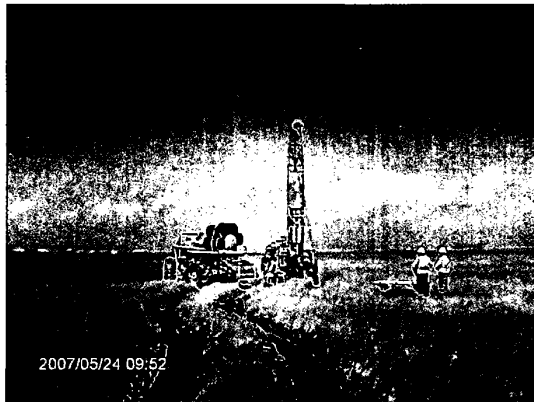
At 1050 hours, MMS began pushing 5-foot core barrels at shallow well location **OMW20** (Appendix A, Photographs 25 – 26). Upon reaching a depth of 15 feet bgs, PBW examined the lithologic samples (Appendix A, Photographs 27 – 28). PBW directed MMS to push the core barrel string down another 2½ feet to 17 feet bgs. PBW noted that the top of the confining clay was at about 15 feet bgs. PBW directed MMS to auger down to a total depth of 16 feet bgs, and set the bottom of the 10-foot screen at 16 feet bgs. After filling the annulus with sand and bentonite, MMS placed a section of 8-inch-diameter surface casing around the open borehole to prevent surface water infiltration (Appendix A, Photograph 29). Installation of OMW20 was completed at 1250 hours.

Photograph 25 Date: 24 May 2007
Site: Gulfco Marine Maintenance Superfund Site
Description: Buggy HSA rig setting up at OMW20

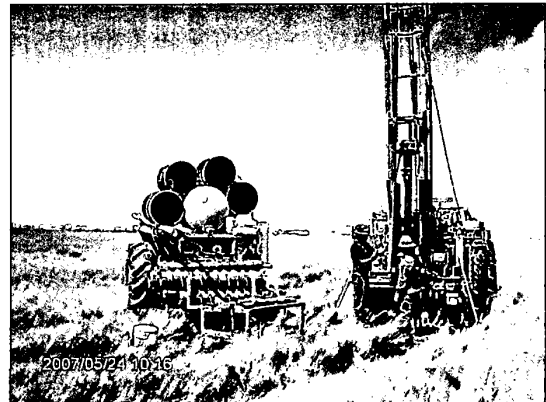
Photograph 26 Date: 24 May 2007
Site: Gulfco Marine Maintenance Superfund Site
Description: Drilling at OMW20 (shallow Zone A well)

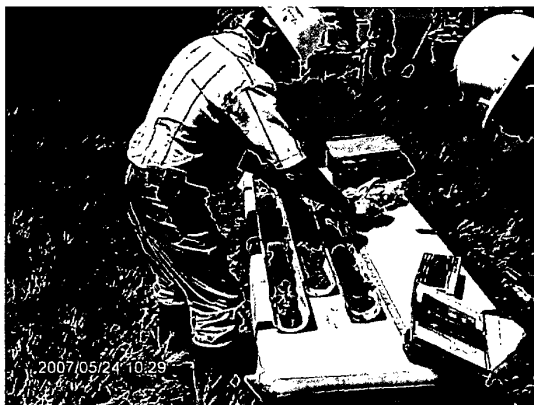
Photograph 27 Date: 24 May 2007
Site: Gulfco Marine Maintenance Superfund Site
Description: Logging cores at OMW20

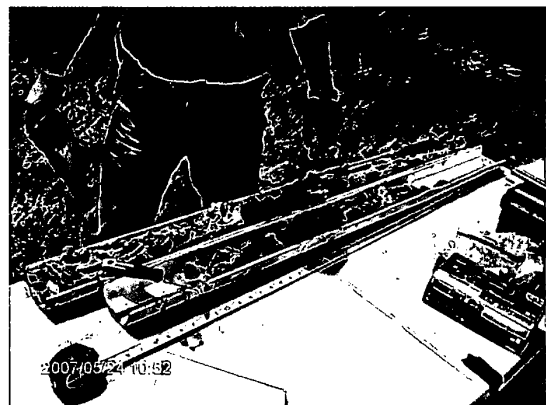
Photograph 28 Date: 24 May 2007
Site: Gulfco Marine Maintenance Superfund Site
Description: Logging cores at OMW20

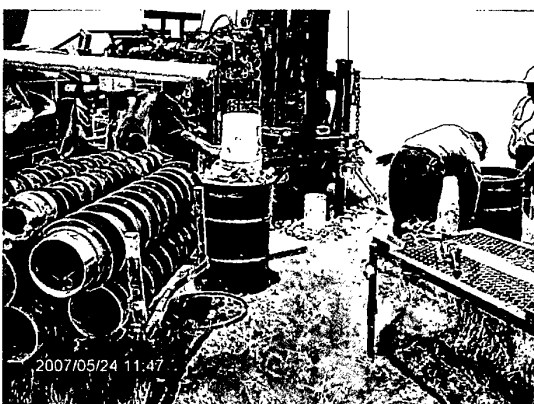
Photograph 29 Date: 24 May 2007
Site: Gulfco Marine Maintenance Superfund Site
Description: Protective surface casing at OMW20 to prevent surface water infiltration

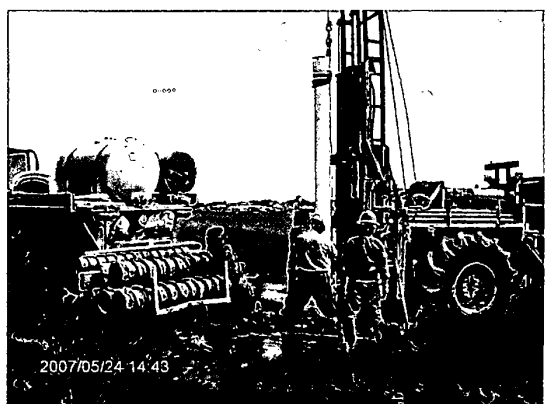
Photograph 30 Date: 24 May 2007
Site: Gulfco Marine Maintenance Superfund Site
Description: Setting 17 feet of surface casing at OMW26B (shallow Zone A well)

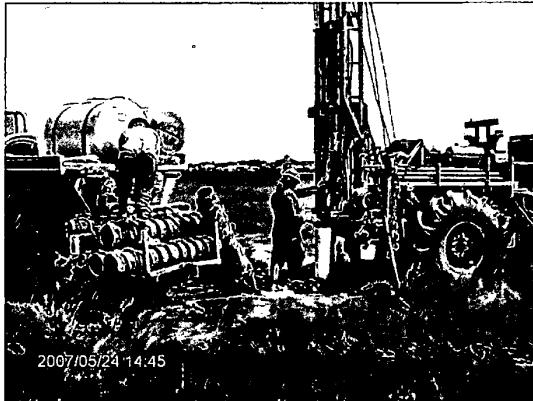
Photograph 31 Date: 24 May 2007
Site: Gulfco Marine Maintenance Superfund Site
Description: Setting surface casing at OMW26B

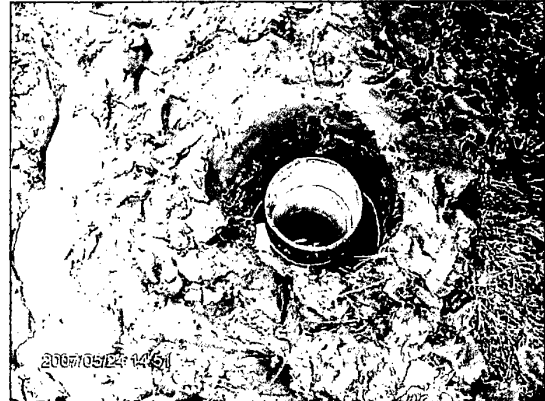
Photograph 32 Date: 24 May 2007
Site: Gulfco Marine Maintenance Superfund Site
Description: Surface casing at OMW26B (8-inch-diameter)

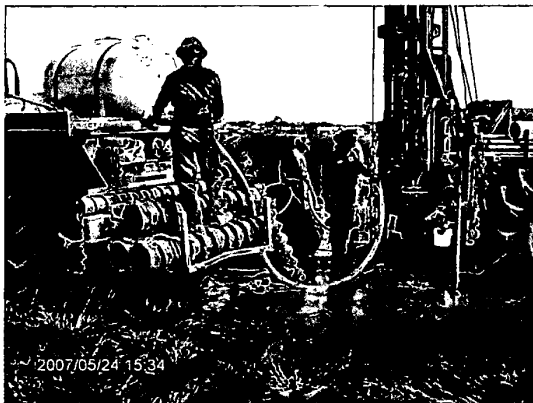
Photograph 33 Date: 24 May 2007
Site: Gulfco Marine Maintenance Superfund Site
Description: Grouting surface casing at OMW26B using a tremie pipe

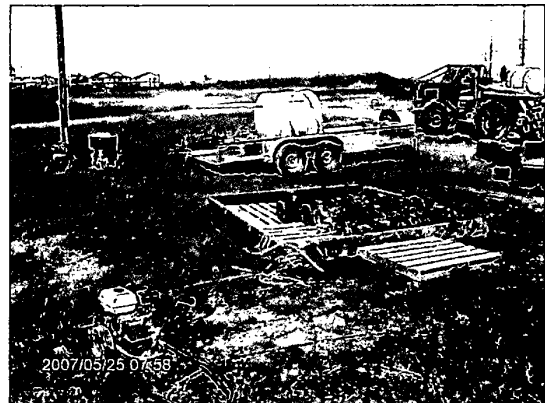
Photograph 34 Date: 25 May 2007
Site: Gulfco Marine Maintenance Superfund Site
Description: Equipment decontamination area

At 1550 hours, MMS began constructing the decontamination (decon) area (Appendix A, Photograph 34) and prepared the all-terrain “buggy” hollow-stem auger (HSA) drilling rig and support vehicle for drilling activities.

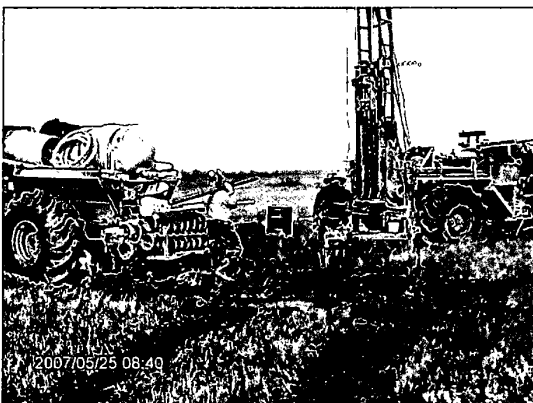
Photograph 35 Date: 25 May 2007
Site: Gulfco Marine Maintenance Superfund Site
Description: Setting up HSA buggy rig at NC2MW28A

At 0935 hours, MMS began pushing 5-foot core barrels at shallow well location **NC2MW28A** (Appendix A, Photographs 35 – 36). Upon reaching a depth of 15 feet bgs, PBW examined the lithologic samples (Appendix A, Photograph 37). PBW directed MMS to set the bottom of the 10-foot screen at 15 feet bgs. After filling the annulus with sand and bentonite, MMS placed a section of 8-inch-diameter surface casing around the open borehole to prevent surface water infiltration.

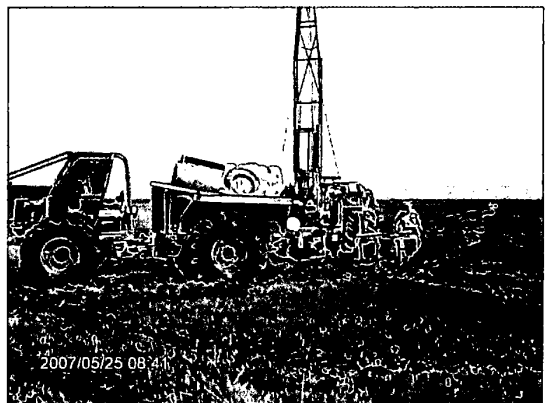
Photograph 36 Date: 25 May 2007
Site: Gulfco Marine Maintenance Superfund Site
Description: Drilling at NC2MW28A (shallow Zone A well)

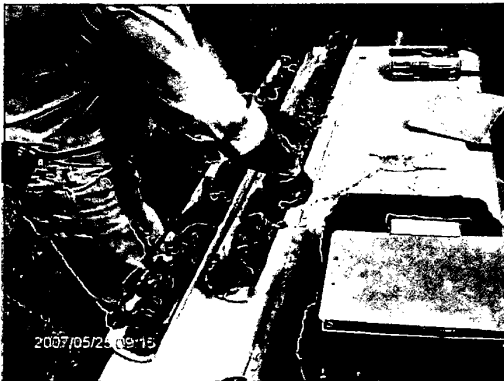
Photograph 37 Date: 25 May 2007
Site: Gulfco Marine Maintenance Superfund Site
Description: Logging cores at NC2MW28A

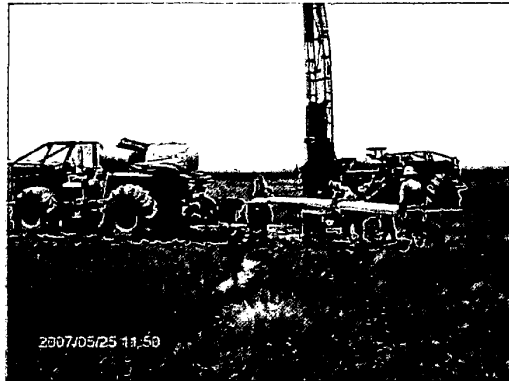
At 1310 hours, MMS began drilling at deep well location **NC2MW23B** using the 12-inch OD HSA (8-inch ID); NC2MW23B is located immediately adjacent to NC2MW28A, which was installed that morning. MMS drilled to a total depth of 15 feet bgs and set the 8-inch-diameter surface casing (Appendix A, Photograph 38). MMS then grouted the casing annulus using a tremie pipe (Appendix A, Photograph 39). Installation of the surface casing for NC2MW23B was completed at 1520 hours.

Photograph 38 Date: 25 May 2007
Site: Gulfco Marine Maintenance Superfund Site
Description: Setting surface casing at NC2MW23B

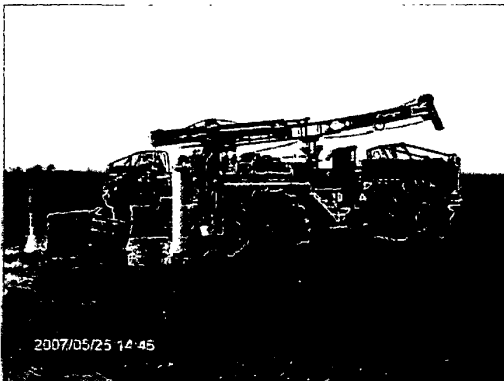
Photograph 39 Date: 25 May 2007
Site: Gulfco Marine Maintenance Superfund Site
Description: Grouting surface casing at NC2MW23B (right); new well NC2MW28A is visible at left

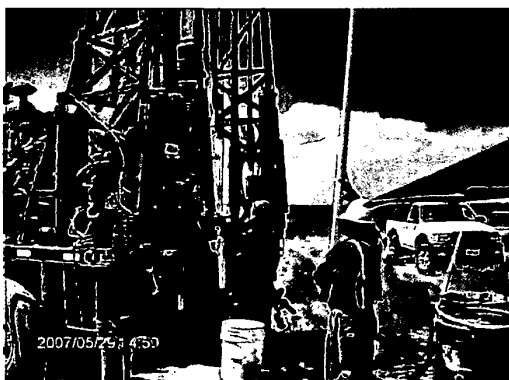
Photograph 42 Date: 29 May 2007
Site: Gulfco Marine Maintenance Superfund Site
Description: Setting well casing at ND4MW24B (2-inch-diameter PVC)

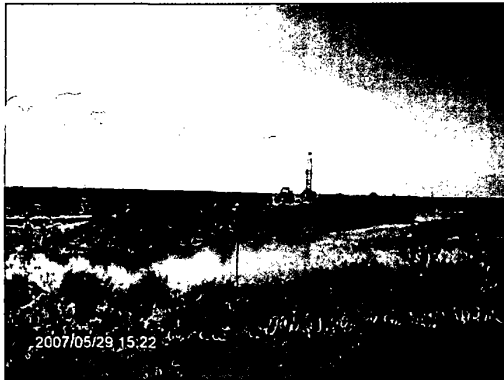
While EA performed oversight of ND4MW24B installation, MMS' other drill crew installed **OMW27B**, which was drilled to a total depth of 30 feet bgs (Appendix A, Photographs 43 – 44). MMS set the 10-foot screen (2-inch-diameter PVC with 0.010-inch slots) from 20 – 30 feet bgs.

Photograph 43 Date: 29 May 2007
Site: Gulfco Marine Maintenance Superfund Site
Description: Second crew installing OMW27B with buggy HSA rig (deep Zone B well)

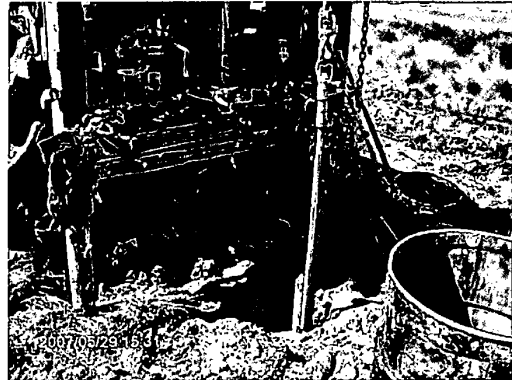
Photograph 44 Date: 29 May 2007
Site: Gulfco Marine Maintenance Superfund Site
Description: Grouting well casing at OMW27B using a tremie pipe

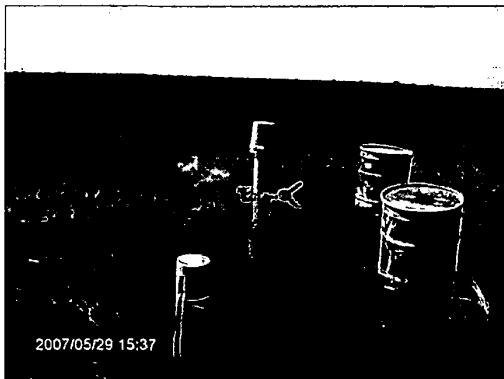
While MMS was resolving some equipment issues at ND4MW24B, EA inspected recently installed well pairs NC2MW28A/NC2MW23B and OMW20/OMW26B (Appendix A, Photographs 45 – 46). EA observed about 1 foot of standing water over wells NC2MW28A and NC2MW23B.

Photograph 45 Date: 29 May 2007
Site: Gulfco Marine Maintenance Superfund Site
Description: Shallow well NC2MW28A (foreground) and deep well NC2MW23B (background)

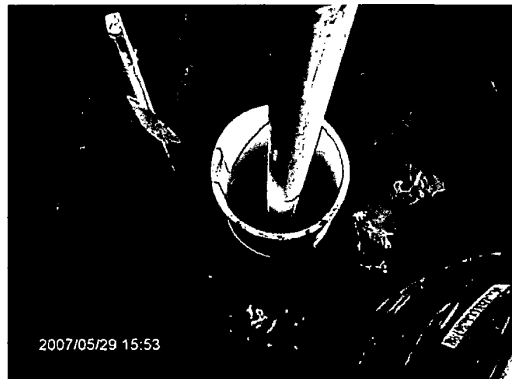
Photograph 46 Date: 29 May 2007
Site: Gulfco Marine Maintenance Superfund Site
Description: Deep well OMW26B

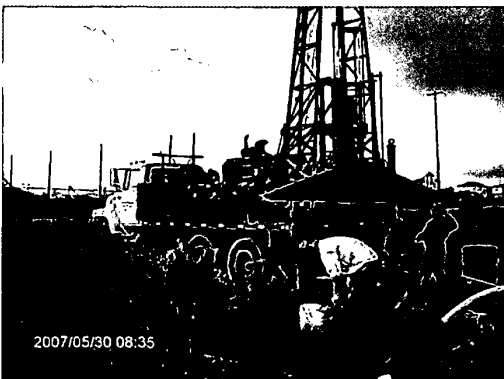
At 0940 hours, MMS began pushing 5-foot core barrels at **NB4MW18** (Appendix A, Photograph 47). Upon reaching a depth of 15 feet bgs, PBW examined the lithologic samples. PBW directed MMS to continue drilling to 19 feet bgs and backfill the borehole with bentonite to 18 feet bgs. MMS then set the bottom of the 10-foot screen (2-inch-diameter PVC with 0.010-inch slots) at 18 feet bgs (Appendix A, Photograph 48). EA noted that MMS personnel were handling the PVC well casing without wearing nitrile gloves. At 1055 hours, MMS backfilled the annulus with sand from total depth to 6 feet bgs, followed by bentonite from 4 – 6 feet bgs and grout from surface to 4 feet bgs.

Photograph 47 Date: 30 May 2007
Site: Gulfco Marine Maintenance Superfund Site
Description: Truck-mounted rig drilling NB4MW18 (shallow Zone A well)

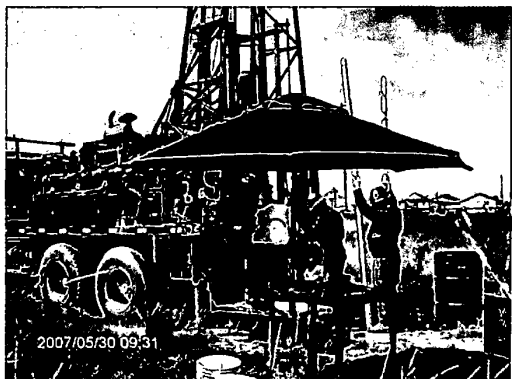
Photograph 48 Date: 30 May 2007
Site: Gulfco Marine Maintenance Superfund Site
Description: Setting well screen and casing at NB4MW18

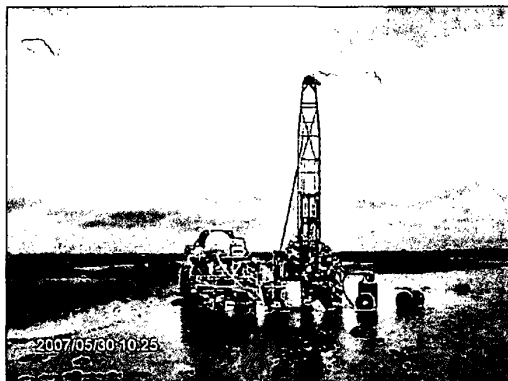
At 1115 hours, EA relocated to the deep well location **NG3MW25B**, where MMS had already drilled deeper within the 8-inch-diameter surface casing that was set and grouted the previous week (Appendix A, Photograph 49). At a depth of 32 feet bgs, MMS encountered the tight clay underlying the Zone B sand. Upon evaluating the lithologic samples collected from 16 – 32 feet bgs, PBW directed MMS to set the 10-foot screen (2-inch-diameter PVC with 0.010-inch slots) from 16 – 26 feet bgs (Appendix A, Photographs 50 – 51). Headspace readings collected from subsurface soil samples using the PID did not exceed 1 part per million (ppm) above the background values.

Photograph 49 Date: 30 May 2007
Site: Gulfco Marine Maintenance Superfund Site
Description: Buggy HSA rig drilling deeper within surface casing at NG3MW25B

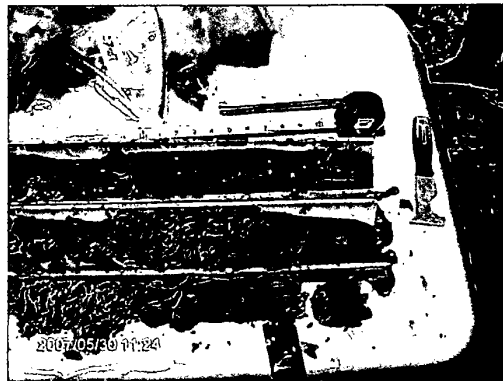
Photograph 50 Date: 30 May 2007
Site: Gulfco Marine Maintenance Superfund Site
Description: Logging cores at NG3MW25B

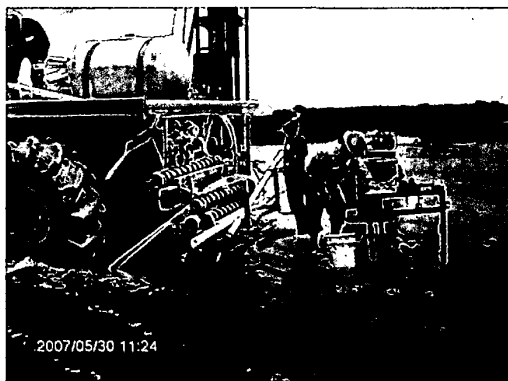
Photograph 51 Date: 30 May 2007
Site: Gulfco Marine Maintenance Superfund Site
Description: Preparing to set well screen and casing at NG3MW25B

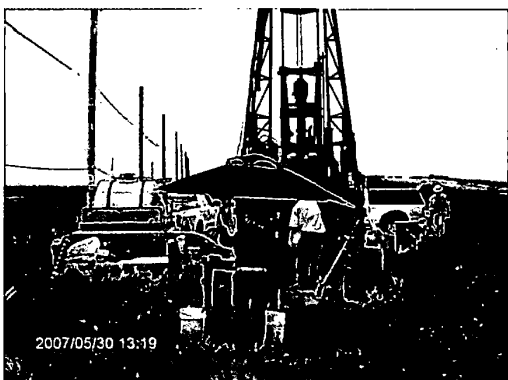
At 1355 hours, MMS installed shallow well **SA4MW22** with the buggy rig. PBW directed MMS to drill down to a total depth of 15 feet bgs and set the 10-foot well screen (2-inch-diameter PVC with 0.010-inch slots) from 5 – 15 feet bgs (Appendix A, Photographs 52 – 53). At 1440 hours, MMS mobilized the rig to the decon area.

Photograph 53 Date: 30 May 2007
Site: Gulfco Marine Maintenance Superfund Site
Description: Filling well annulus with sand at SA4MW22

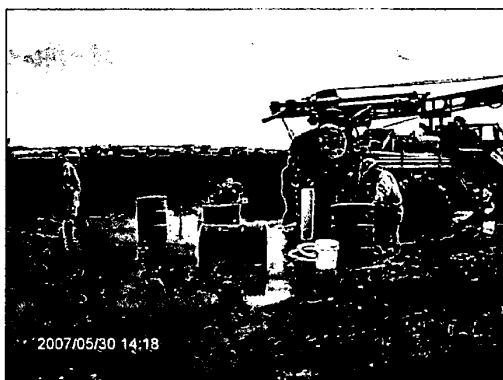
At approximately 1515 hours, MMS set up the buggy rig on **OMW26B** to drill deeper within the surface casing that was set and grouted the previous week (Appendix A, Photographs 54 – 55). Upon evaluating the lithologic samples collected from 17 – 40 feet bgs, PBW established that they had not encountered the Zone B aquifer in this area of the site (Appendix A, Photograph 56). EPA and PBW discussed whether to P&A well OMW26B, since no definable Zone B sand had been encountered at a depth interval of 20 – 25 feet bgs—only tight clays. According to PBW, if any other sand interval were encountered in this vicinity, it would be difficult to correlate with other Zone B wells; in addition, analytical data would not be relevant with regard to contaminant transport within the Zone B sand. At 1805 hours, PBW then directed MMS to grout the borehole to total depth. MMS partially grouted the borehole with the augers in place; however, MMS did not have sufficient materials on the service truck to complete grouting activities. MMS would complete grouting activities at this well the following day.

Photograph 54 Date: 30 May 2007
Site: Gulfco Marine Maintenance Superfund Site
Description: Setting up buggy HSA rig at OMW26B

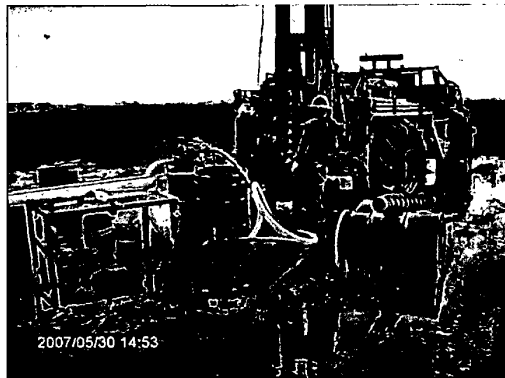
Photograph 55 Date: 30 May 2007
Site: Gulfco Marine Maintenance Superfund Site
Description: Drilling deeper within surface casing at OMW26B

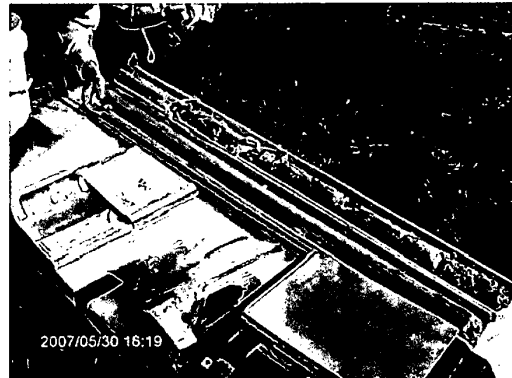
Photograph 56 Date: 30 May 2007
Site: Gulfco Marine Maintenance Superfund Site
Description: Logging cores at OMW26B

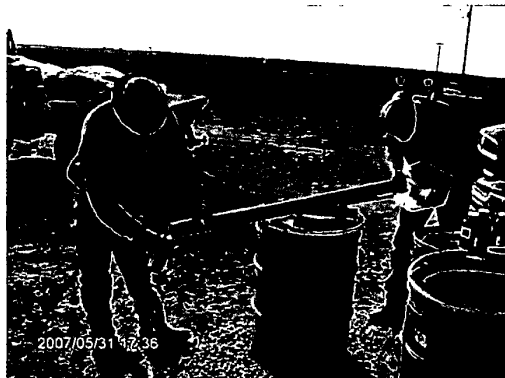
At 0800 hours, EA and EPA arrived at the Gulfco site. According to PBW, one MMS crew would continue drilling activities while the other would work on surface completions. PBW collected an equipment rinsate blank sample from one of the decontaminated 5-foot-long core barrels (Appendix A, Photograph 57).

Photograph 57 Date: 31 May 2007
Site: Gulfco Marine Maintenance Superfund Site
Description: PBW collecting equipment rinsate blank from decontaminated, 5-foot-long core barrel

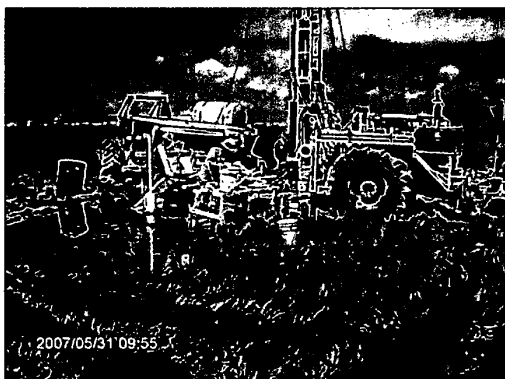
At 1010 hours, MMS set up the buggy rig at **NC2MW23B** to drill deeper within the surface casing that was set and grouted the previous week (Appendix A, Photograph 59). Upon evaluating the lithologic samples collected from 15 – 40 feet bgs, PBW established that they had not encountered the Zone B aquifer in this area of the site (Appendix A, Photograph 60). At 1333 hours, PBW directed MMS to plug and abandon (P&A) well NC2MW23B.

Photograph 59 Date: 31 May 2007
Site: Gulfco Marine Maintenance Superfund Site
Description: Drilling deeper within surface casing at NC2MW23B

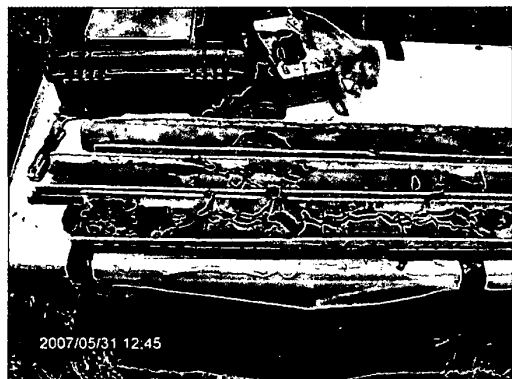
Photograph 60 Date: 31 May 2007
Site: Gulfco Marine Maintenance Superfund Site
Description: Logging cores at NC2MW23B

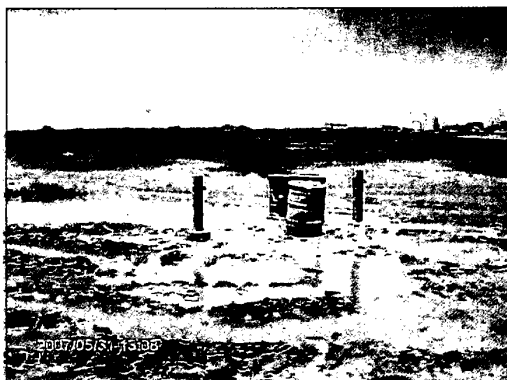
Photograph 61 Date: 31 May 2007
Site: Gulfco Marine Maintenance Superfund Site
Description: Surface completions for NG3MW25B (left) and NG3MW19 (right)

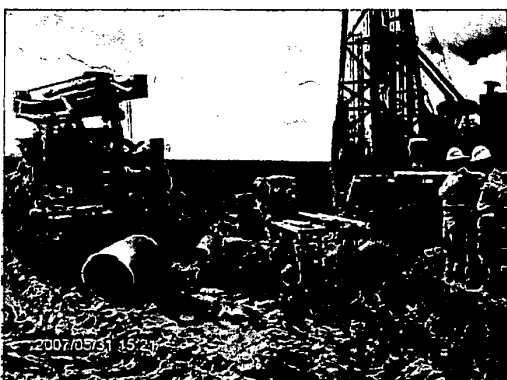
Photograph 65 Date: 31 May 2007
Site: Gulfco Marine Maintenance Superfund Site
Description: Drilling ND3MW29A (shallow Zone A well)

At 1615 hours, MMS began installation of shallow well **ND3MW29A** (Appendix A, Photograph 65). Upon evaluating the lithologic samples collected from 0 – 17½ feet bgs, PBW directed MMS to set the 10-foot well screen (2-inch-diameter PVC with 0.010-inch slots) from 7½ – 17½ feet bgs. Headspace field screening of subsurface soil samples collected from ND3MW29A with a PID detected VOCs at 884 ppm in the underlying silty clay (16 feet bgs) and 585 ppm in the sand interval (12½ – 13½ feet bgs) (Appendix A, Photograph 66). During lithologic sampling, PBW noted a discolored dark brown sand interval (strong hydrocarbon odor and visible sheen) from 12½ – 17½ feet bgs (Appendix A, Photographs 67 – 68). PBW collected a soil sample from the upper half of this interval for laboratory analysis for VOCs, SVOCs, and pesticides (Appendix A, Photographs 69 – 70); EA had not been tasked with obtaining any split soil samples. PBW suspects the presence of non-aqueous phase liquid (NAPL), especially since the well is located near the south corner of the capped impoundment.

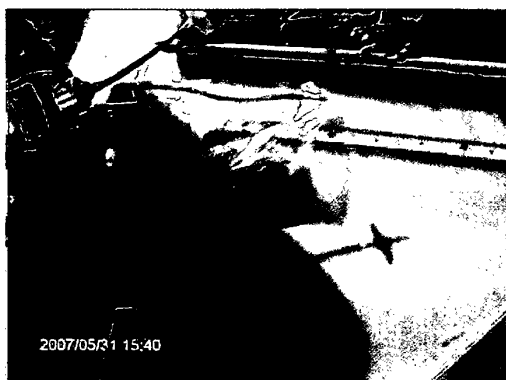
Photograph 66 Date: 31 May 2007
Site: Gulfco Marine Maintenance Superfund Site
Description: Headspace field screening of soil with PID

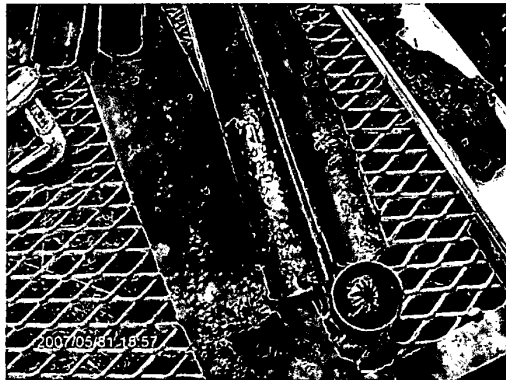
Photograph 67 Date: 31 May 2007
Site: Gulfco Marine Maintenance Superfund Site
Description: Non-aqueous phase liquid (NAPL) residue visibly evident within core barrel at ND3MW29A

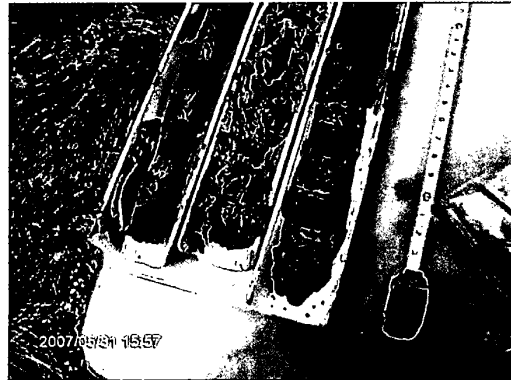
Photograph 68 Date: 31 May 2007
Site: Gulfco Marine Maintenance Superfund Site
Description: Lithologic samples from ND3MW29A; note visible NAPL in soil core sample on far right

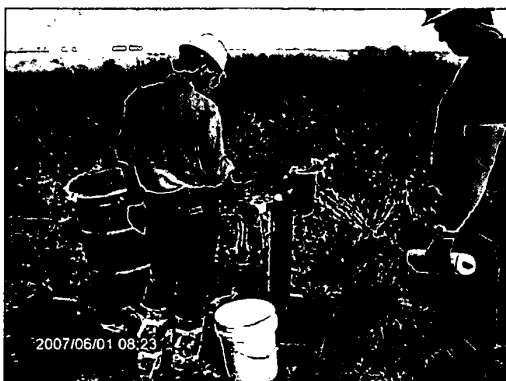
Photograph 70 Date: 31 May 2007
Site: Gulfco Marine Maintenance Superfund Site
Description: PBW collecting analytical soil sample using EnCore sampler (VOC analysis) (ND3MW29A)

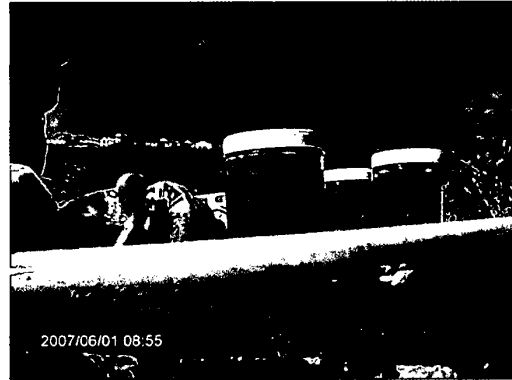
Photograph 74 Date: 1 June 2007
Site: Gulfco Marine Maintenance Superfund Site
Description: Sample of ground water collected from ND3MW29A (for visual inspection only)

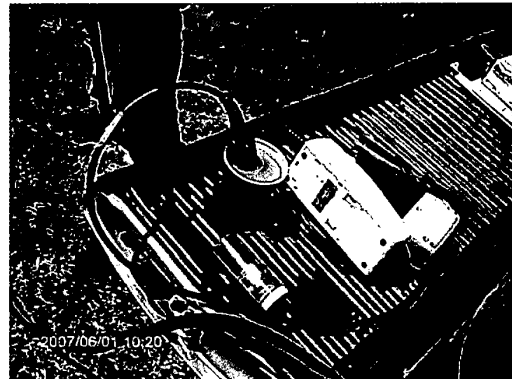
Photograph 76 Date: 1 June 2007
Site: Gulfco Marine Maintenance Superfund Site
Description: Measuring water quality at SA4MW22 during development activities

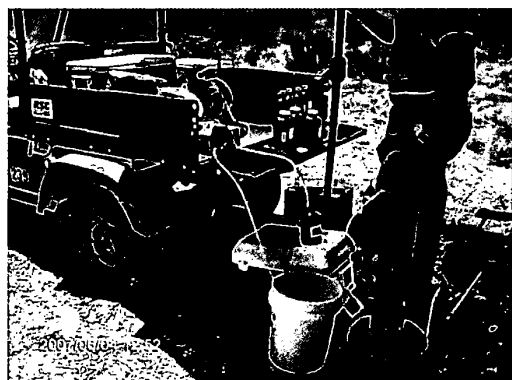
Photograph 77 Date: 4 June 2007
Site: Gulfco Marine Maintenance Superfund Site
Description: Low-flow ground water sampling at OMW27B

At 1305 hours, PBW gauged deep well **OMW27B** with a Keck® water level indicator; depth to water was 3.09 feet btoc. At 1312 hours, PBW initiated low-flow purging activities maintaining a flow rate of 0.2 liter per minute. Purging was accomplished with a Geotech® GeoPump 2 peristaltic sampling pump and Teflon® tubing; the pump intake (tubing) was set at the middle of the screen interval (Appendix A, Photograph 77). After 10 minutes of low-flow purging, PBW began monitoring water quality parameters at 5-minute intervals using a YSI® water quality meter (Model No. 556MPS) and a Hach® turbidimeter (Model No. 2100P). EA noted that the purge water from OMW27B was clear. At 1345 hours, PBW began sample collection at OMW27B; EA noted the split sample collection time as 1400 hours (Appendix A, Photograph 78). PBW collected ground water samples for VOC, SVOC, pesticides, and metals analyses at this well. EA obtained a split sample for the following laboratory analyses:

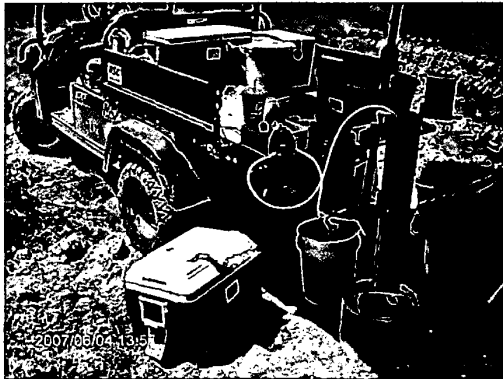
Photograph 78 Date: 4 June 2007
Site: Gulfco Marine Maintenance Superfund Site
Description: Collecting analytical samples at OMW27B

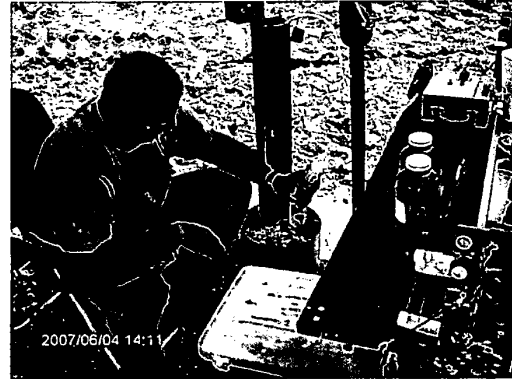
Photograph 80 Date: 4 June 2007
Site: Gulfco Marine Maintenance Superfund Site
Description: Collecting analytical samples at OMW21;
using 10-µm filter to collect metals aliquot

At 1430 hours, PBW gauged shallow well **OMW21**; depth to water was 4.02 feet btoc. At 1440 hours, PBW initiated low-flow purging activities, as previously outlined. EA noted that the purge water was slightly cloudy. From 1510 – 1545 hours, PBW filled PBW and EA sample containers at OMW21; EA noted the split sample collection time as 1530 hours (Appendix A, Photograph 79). PBW only collected ground water samples for VOC and pesticides analyses at this well; however, EA obtained sufficient split sample volume for analysis for VOCs, SVOCs, pesticides, and metals. Because the stabilized turbidity reading for OMW21 ground water exceeded 10 NTUs, PBW filtered the split metals aliquot for EA using a Geotech® 10-micron (µm), high-capacity disposable filter (as per PBW's SAP) (Appendix A, Photograph 80). PBW and EA placed sample containers within a cooler containing bagged ice.

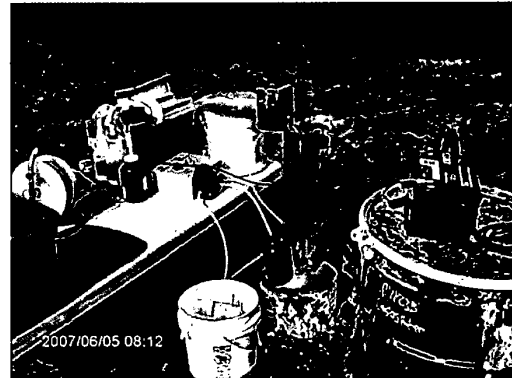
Photograph 81 Date: 5 June 2007
Site: Gulfco Marine Maintenance Superfund Site
Description: Low-flow ground water sampling at NC2MW28A

At 0825 hours, PBW gauged shallow well **NC2MW28A**; depth to water was 2.57 feet btoc. At 0833 hours, PBW initiated low-flow purging activities, as previously outlined (Appendix A, Photograph 81). EA noted that the purge water initially contained elevated sediment content, which eventually became clearer. From 0858 – 0937 hours, PBW filled PBW and EA sample containers at NC2MW28A; EA noted the split sample collection time as 0930 hours (Appendix A, Photograph 82). PBW only collected ground water samples for VOC and pesticides analyses at this well; however, EA obtained sufficient split sample volume for analysis for VOCs, SVOCs, pesticides, and metals. Because the stabilized turbidity reading for NC2MW28A ground water exceeded 10 NTUs, PBW filtered the split metals aliquot for EA using a 10-µm filter (as per PBW's SAP). PBW and EA placed sample containers within a cooler containing bagged ice.

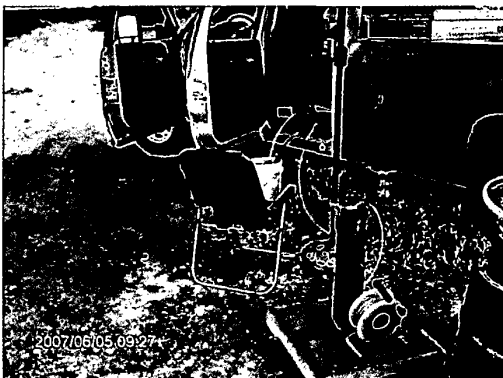
Photograph 82 Date: 5 June 2007
Site: Gulfco Marine Maintenance Superfund Site
Description: Collecting analytical samples at NC2MW28A

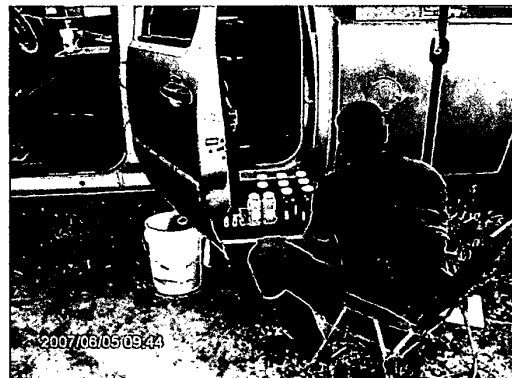
Photograph 83 Date: 5 June 2007
Site: Gulfco Marine Maintenance Superfund Site
Description: Low-flow ground water sampling at ND4MW24B

At 1000 hours, PBW gauged deep well **ND4MW24B**; depth to water was 3.66 feet btoc. At 1020 hours, PBW initiated low-flow purging activities, as previously outlined (Appendix A, Photograph 83). From 1041 – 1125 hours, PBW filled PBW sample containers at ND4MW24B. PBW collected ground water samples (including a field duplicate) for VOC, SVOC, pesticides, and metals analyses at this well (Appendix A, Photograph 84). EA was not tasked with obtaining a split sample at this location. Because the stabilized turbidity reading for ND4MW24B ground water exceeded 10 NTUs, PBW filtered the metals aliquot using a 10-µm filter (as per PBW's SAP). PBW placed sample containers within a cooler containing bagged ice.

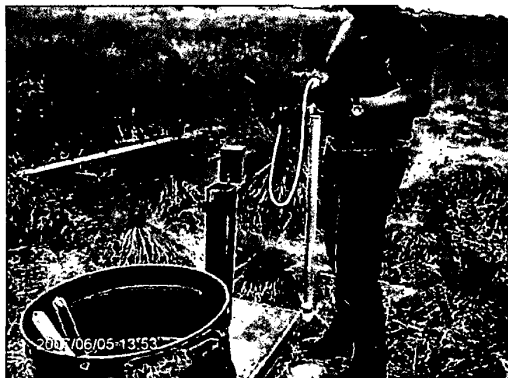
Photograph 85 Date: 5 June 2007
Site: Gulfco Marine Maintenance Superfund Site
Description: Collecting sample from ND3MW29A using disposable bailer (for visual inspection only)

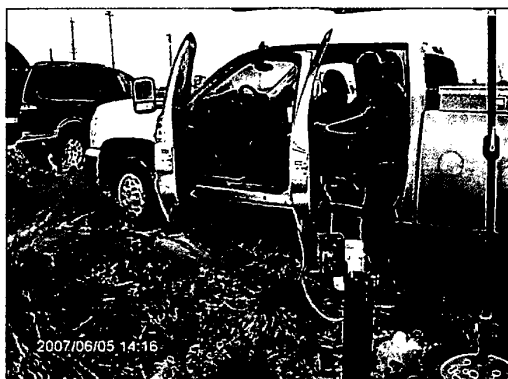
Photograph 87 Date: 5 June 2007
Site: Gulfco Marine Maintenance Superfund Site
Description: Low-flow ground water sampling at ND3MW29A

At 1516 hours, PBW initiated low-flow purging activities at **ND3MW29A**, as previously outlined (Appendix A, Photograph 87). From 1533 – 1615 hours, PBW filled PBW and EA sample containers at ND3MW29A; EA noted the split sample collection time as 1615 hours. PBW only collected ground water samples for VOC and pesticides analyses at this well; however, EA obtained sufficient split sample volume for analysis for VOCs, SVOCs, pesticides, and metals. Because the stabilized turbidity reading for ND4MW29A ground water exceeded 10 NTUs, PBW filtered EA's metals aliquot using a 10-µm filter (as per PBW's SAP). PBW also collected a field blank at ND4MW29A, and an equipment rinsate blank on the water level indicator. PBW and EA placed sample containers within a cooler containing bagged ice.
